**Flood Control Project Maintenance
Levee Inspections**

Fall 2015 Levee Maintenance Deficiency Summary Report

Sacramento River Basin

Reclamation District No. 0501 Ryer Island

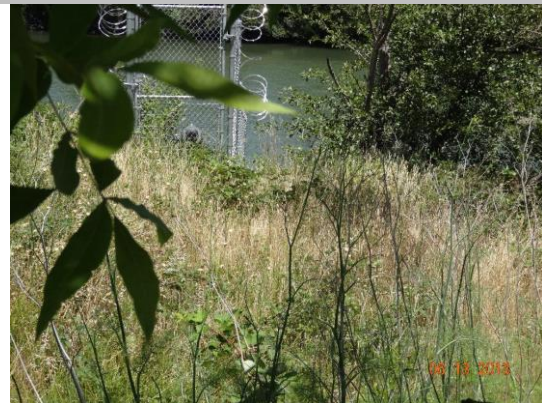
Photo 1 of 3 : UCIP_FA_2015_2086.jpg

LM Start	7.22	Rating **	M	Issue No.	153
LM End	7.22	Issue Type +	En	Location *	LS
Category	Supplemental			GPS Latitude/Longitude	
				Start	End
Item	DWR UCIP Field Study			38.287837 °	38.287837 °
				-121.613453 °	-121.613453 °
DWR ID					
Action/Comments					
Inspector Comments: FS_ID:46834 DS_ID:21061 EP_NO: N/A FS_HLM: 7.345 Repair Type: Non-Urgent Crossing Status: Found UCIP Comments: 11/19/2015 DWR Inspector (H. Phillips) coordinated with LMA superintendent and the owner for this crossing is Walter Koeing, APN No. 042220040. According to LMA superintendent owner installed filter system with fence on landward side and fence around pump in 2012. Pipe not replaced in 2012, this pipe would be a good candidate for internal inspection since the installation date for this crossing was recorded as 1946.06/13/2013 Conduit visible on landward side; new gate on WS toe; filtration system with security fence; Pipe has been upgraded--need permit authorizing work and owner. Dense vegetation limits the inspector's visibility to identify signs of pipe failure (leaks) along the waterward slope. Recommend removing vegetation along pipe alignment to conduct proper inspection of structure and appurtenances. FIELD_STRUCT_DESC: 8-inch steel pipe through the levee, 3.7 feet below the crown. Siphon breaker and service pole on landward slope. 2-inch conduit runs parallel to 8-inch steel pipe. Pump in pump house on waterward slope. (USACE-1959). This entry matches the Drainage or Irrigation Structure referenced in O&M manual (HLM 8.00). FS Date: 06/13/2013

Pipe section near toe is protected by security fence.

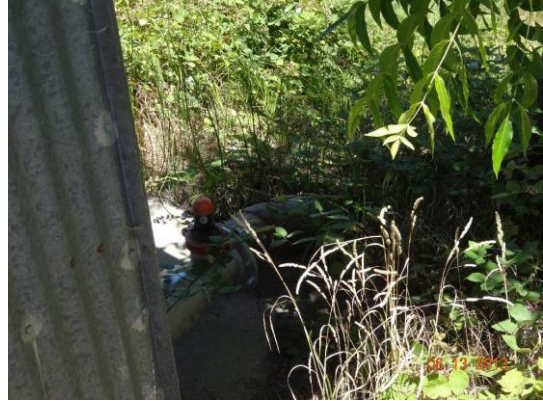
Photo 2 of 3 : UCIP_FA_2015_2087.jpg

Action/Comments					
Inspector Comments: FS_ID:46834 DS_ID:21061 EP_NO: N/A FS_HLM: 7.345 Repair Type: Non-Urgent Crossing Status: Found UCIP Comments:11/19/2015 DWR Inspector (H. Phillips) coordinated with LMA superintendent and the owner for this crossing is Walter Koeing, APN No. 042220040. According to LMA superintendent owner installed filter system with fence on landward side and fence around pump in 2012. Pipe not replaced in 2012, this pipe would be a good candidate for internal inspection since the installation date for this crossing was recorded as 1946.06/13/2013 Conduit visible on landward side; new gate on WS toe; filtration system with security fence; Pipe has been upgraded--need permit authorizing work and owner. Dense vegetation limits the inspector's visibility to identify signs of pipe failure (leaks) along the waterward slope. Recommend removing vegetation along pipe alignment to conduct proper inspection of structure and appurtenances. FIELD_STRUCT_DESC: 8-inch steel pipe through the levee, 3.7 feet below the crown. Siphon breaker and service pole on landward slope. 2-inch conduit runs parallel to 8-inch steel pipe. Pump in pump house on waterward slope. (USACE-1959). This entry matches the Drainage or Irrigation Structure referenced in O&M manual (HLM 8.00). FS Date: 06/13/2013

Pipe connection after pump station.

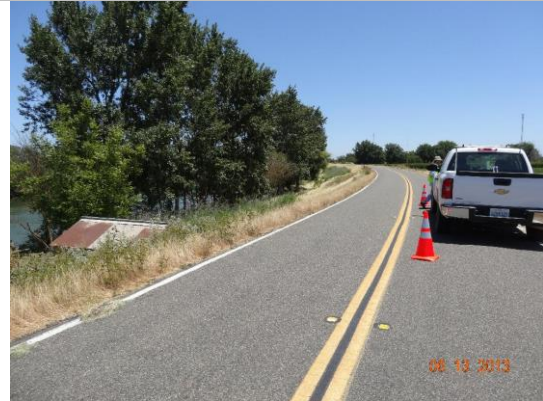
Photo 3 of 3 : UCIP_FA_2015_2088.jpg

Overview of levee crown.

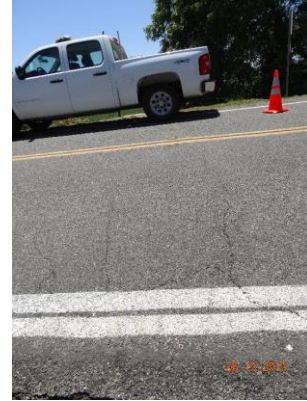
Photo 2 of 3 : UCIP_FA_2015_4031.jpg

Item	DWR UCIP Field Study			38.286153 °	38.286153 °	
				-121.607959 °	-121.607959 °	
DWR ID						
Action/Comments						
Inspector Comments: FS_ID:32545 DS_ID:21063 EP_NO: 11812 FS_HLM: 7.72 Repair Type: Urgent Crossing Status: Found UCIP Comments: Open cut section of levee on LS slope 8 foot wide--repair work needed. Abandoned pump on waterward berm. Dense vegetation--Recommend removing vegetation along pipe alignment to conduct proper inspection of structure and appurtenances on waterward side. FIELD_STRUCT_DESC: 14-inch steel pipe and 1.25-inch electrical conduit through the levee, both 3.0 feet below the crown. Cutoff wall around pipe and conduit at center of levee. Siphon breaker on apex of pipe at landward shoulder. Slant pump on waterward slope. Discharge structure at landward toe. Rock revetment on waterward slope. (Permit No. 11812-1976) FS Date: 06/07/2013

View of levee crown at crossing.

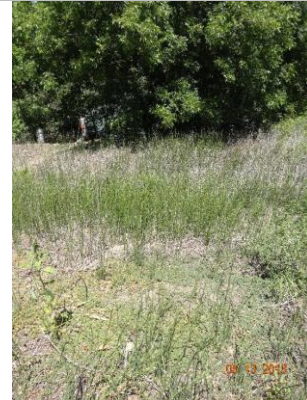
Photo 3 of 3 : UCIP_FA_2015_4032.jpg

View of waterward side--pump located at the berm edge.

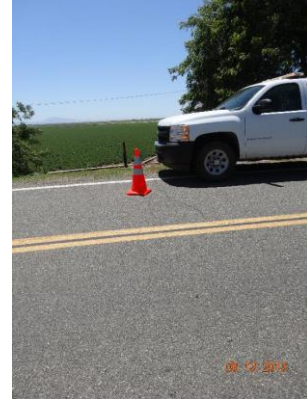
Photo 1 of 3 : UCIP_FA_2015_3673.jpg

View of levee crown at crossing.

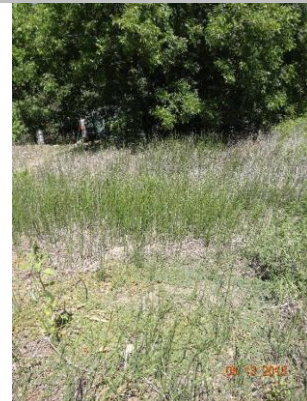
Photo 2 of 3 : UCIP_FA_2015_3674.jpg

View of waterward side--dense vegetation limits visibility of 8-inch steel pipe. Pump belongs to another crossing.

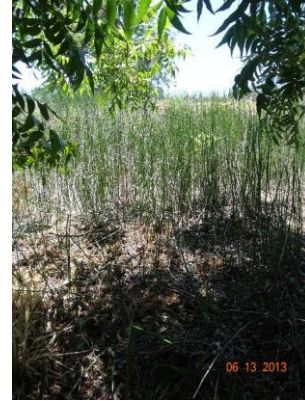
Photo 3 of 3 : UCIP_FA_2015_3675.jpg

View of waterward side looking up at levee shoulder.

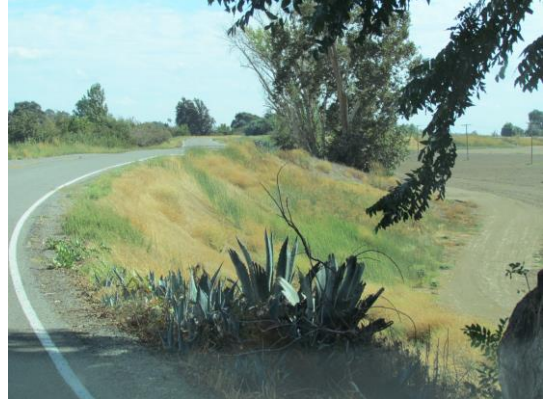
Photo 1 of 1 : FA_2015_RD0501_172_5_20151006_00005.jpg

LM Start	0.00	Rating **	A	Issue No.	5
LM End	2.16	Issue Type +	Ma	Location *	LS
Category	Earthen Levee			GPS Latitude/Longitude	
				Start	End
Item	Vegetation			38.285591 °	38.256225 °
				-121.606317 °	-121.600900 °
DWR ID	DWR_RD0501_04_s_2012_5				
Action/Comments					
Remove the wild growth other than native grasses from the levee slopes. Inspector Comments: RD 501 Has done a great job of removing the wild grasses from the landward slope.

Unit 4 RD 501 looking downstream from levee mile 0.00.

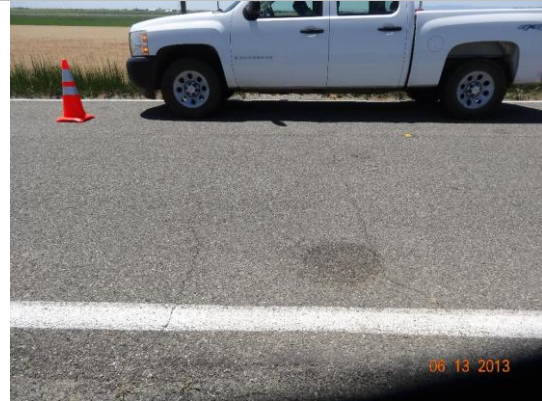
Photo 1 of 3 : UCIP_FA_2015_3501.jpg

Action/Comments					
Inspector Comments: FS_ID:32547 DS_ID:21080 EP_NO: 18135 FS_HLM: 0.558 Repair Type: Non-Urgent Crossing Status: Found UCIP Comments: Cracks visible on levee crown could be associated with pipe vibration or settlement. Burrow activity on landward side. Recommend removing vegetation along pipe alignment on landward side to conduct proper inspection of structure and appurtenances. FIELD_STRUCT_DESC: 10-inch iron pipe through the levee, 3.5 feet below the crown. Cutoff wall around pipe at landward shoulder. Slant pump and pump house on waterward slope. Concrete standpipe and power pole at landward toe. Service pole on landward slope. Pipe exposed on both slopes. (Permit No. 2446-1957) Section of pipe under levee crown, between both shoulders, was removed and replaced with a 10-inch steel pipe under Permit No. 18135 (2006). Two crossings nearby 10-inch pipe and 8-inch pipe crossings are approximately 5 feet apart. FS Date: 06/07/2013

View of levee crown.

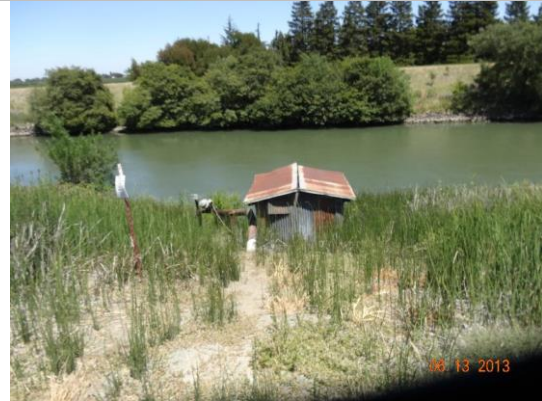
Photo 2 of 3 : UCIP_FA_2015_3502.jpg

Inspector Comments: FS_ID:32547
 DS_ID:21080
 EP_NO: 18135
 FS_HLM: 0.558
 Repair Type: Non-Urgent
 Crossing Status: Found
 UCIP Comments: Cracks visible on levee crown could be associated with pipe vibration or settlement. Burrow activity on landward side. Recommend removing vegetation along pipe alignment on landward side to conduct proper inspection of structure and appurtenances.
 FIELD_STRUCT_DESC: 10-inch iron pipe through the levee, 3.5 feet below the crown. Cutoff wall around pipe at landward shoulder. Slant pump and pump house on waterward slope. Concrete standpipe and power pole at landward toe. Service pole on landward slope. Pipe exposed on both slopes. (Permit No. 2446-1957) Section of pipe under levee crown, between both shoulders, was removed and replaced with a 10-inch steel pipe under Permit No. 18135 (2006). Two crossings nearby 10-inch pipe and 8-inch pipe crossings are approximately 5 feet apart.

Overview of waterward side--2 crossings located within 5 feet.

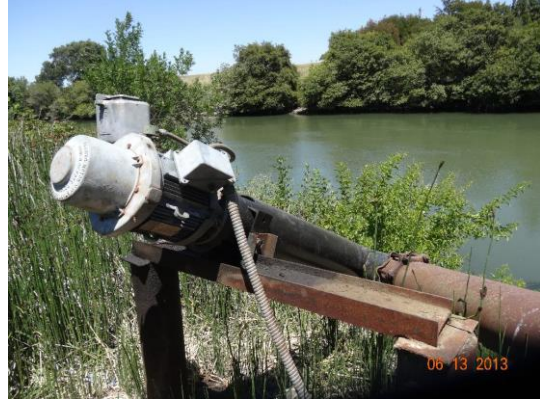
Photo 3 of 3 : UCIP_FA_2015_3503.jpg

Inspector Comments: FS_ID:32547
 DS_ID:21080
 EP_NO: 18135
 FS_HLM: 0.558
 Repair Type: Non-Urgent
 Crossing Status: Found
 UCIP Comments: Cracks visible on levee crown could be associated with pipe vibration or settlement. Burrow activity on landward side. Recommend removing vegetation along pipe alignment on landward side to conduct proper inspection of structure and appurtenances.
 FIELD_STRUCT_DESC: 10-inch iron pipe through the levee, 3.5 feet below the crown. Cutoff wall around pipe at landward shoulder. Slant pump and pump house on waterward slope. Concrete standpipe and power pole at landward toe. Service pole on landward slope. Pipe exposed on both slopes. (Permit No. 2446-1957) Section of pipe under levee crown, between both shoulders, was removed and replaced with a 10-inch steel pipe under Permit No. 18135 (2006). Two crossings nearby 10-inch pipe and 8-inch pipe crossings are approximately 5 feet apart.

Slant pump located on waterward side. 10 inch pipe connects at an angle to tar coated pipe.

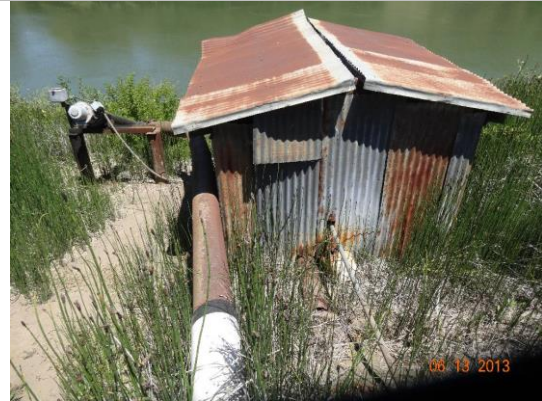
Photo 1 of 3 : UCIP_FA_2015_3504.jpg

Inspector Comments: FS_ID:32548
 DS_ID:21079
 EP_NO: 2446
 FS_HLM: 0.56
 Repair Type: Non-Urgent
 Crossing Status: Found
 UCIP Comments: Permit documents indicate that pipe does not appear to be properly grouted. Crossing needs to be properly abandoned per CVFPB Title 23--need to find owner. Also recommend removing vegetation along pipe alignment to conduct proper inspection of structure and appurtenances.
 FIELD_STRUCT_DESC: Abandoned 8-inch steel pipe through the levee, 6.0 feet below the crown. Pump on waterward side. Steel plate welded on waterward end. (USACE-1959). This entry matches the Drainage or Irrigation Structure referenced in O&M manual (HLM 0.60). Pipe was abandoned under Permit No. 2446 (1957). 10-inch steel pipe is located approximately 5 feet downstream.
 FS Date: 06/13/2013

Pump house is associated with abandoned 8 inch pipe.

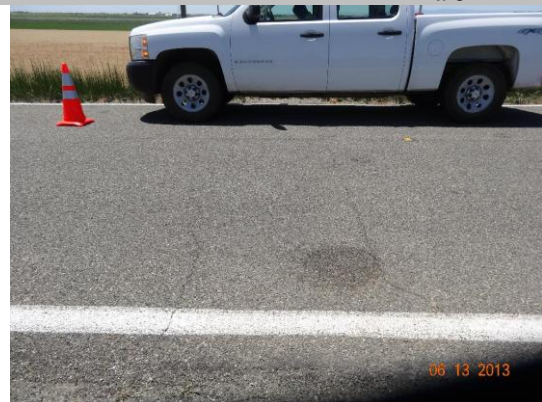
Photo 2 of 3 : UCIP_FA_2015_3505.jpg

View of levee crown at crossing.

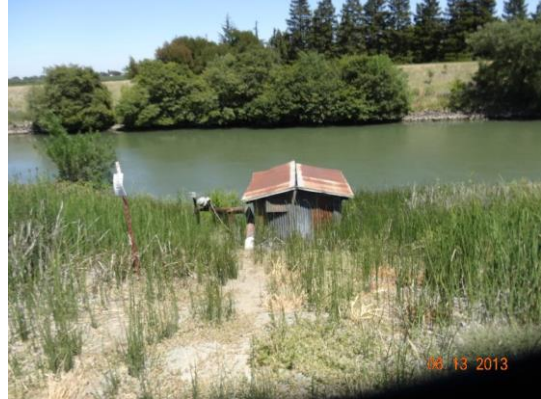
Photo 3 of 3 : UCIP_FA_2015_3539.jpg

Overview of waterward side. Two crossings, 10 inch and 8 inch pipelines, less than 5 feet apart.

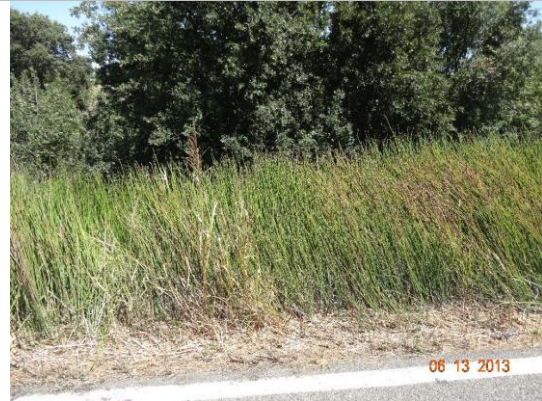
Photo 1 of 3 : UCIP_FA_2015_3540.jpg

LM Start	1.04	Rating **	U	Issue No.	69
LM End	1.04	Issue Type +	En	Location *	LS
Category	Supplemental			GPS Latitude/Longitude	
				Start	End
Item	DWR UCIP Field Study			38.272053 °	38.272053 °
				-121.604176 °	-121.604176 °
DWR ID					
Action/Comments					
Inspector Comments: FS_ID:32549					
DS_ID:21072					
EP_NO: N/A					
FS_HLM: 1.06					
Repair Type: Urgent					
Crossing Status: Found					
UCIP Comments: Pipe has deteriorated-holes present on landward side. Need to contact owner. Unable to determine if crossing is still being used. Dense vegetation limits the inspector's visibility to identify signs of pipe failure (leaks) along the waterward slope. Recommend removing vegetation along pipe alignment to conduct proper inspection of structure and appurtenances.					
FIELD_STRUCT_DESC: Abandoned 8-inch steel pipe through the levee, 2.7 feet below the crown. Pump on waterward side. Steel plate welded on waterward end. (USACE-1959). This entry matches the Drainage or Irrigation Structure referenced in O&M manual (HLM 1.10).

High vegetation along waterward side.

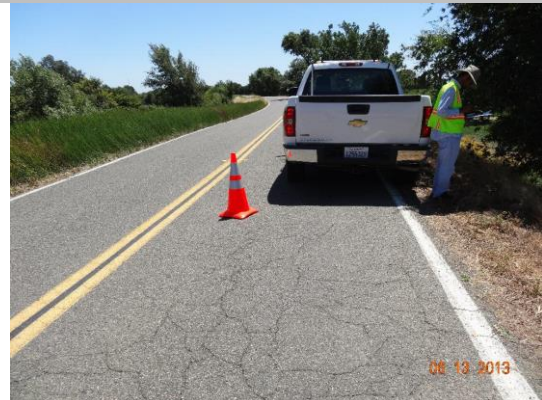
Photo 2 of 3 : UCIP_FA_2015_3541.jpg

View of levee crown at crossing.

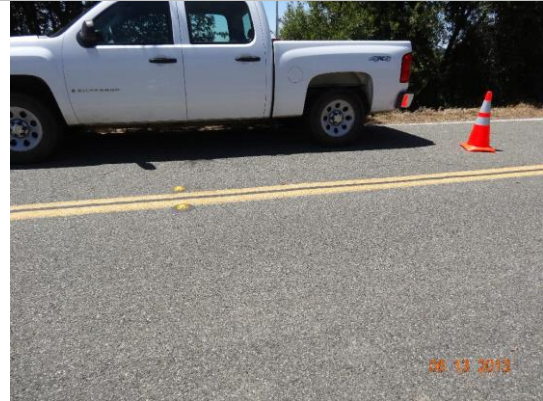
Photo 3 of 3 : UCIP_FA_2015_3542.jpg

View of levee crown at crossing.

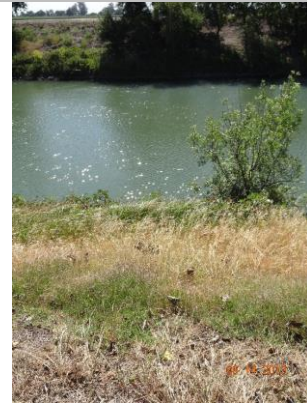
Photo 1 of 3 : UCIP_FA_2015_3543.jpg

LM Start	1.08	Rating **	M	Issue No.	70
LM End	1.08	Issue Type +	En	Location *	LS
Category	Supplemental			GPS Latitude/Longitude	
				Start	End
Item	DWR UCIP Field Study			38.271400 °	38.271400 °
				-121.604368 °	-121.604368 °
DWR ID					
Action/Comments					
Inspector Comments: FS_ID:32550 DS_ID:21073 EP_NO: N/A FS_HLM: 1.11 Repair Type: Non-Urgent Crossing Status: Indicator Found UCIP Comments: Unable to determine if the pipe goes through the levee. need As-Built drawings; Need owner information. FIELD_STRUCT_DESC: 1.5-inch conduit through the levee, 2.0 feet below the crown. Pole and anchor on landward slope. FS Date: 06/13/2013

View of waterward side.

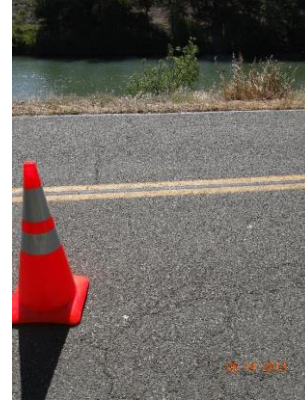
Photo 2 of 3 : UCIP_FA_2015_3544.jpg

Levee crown at crossing.

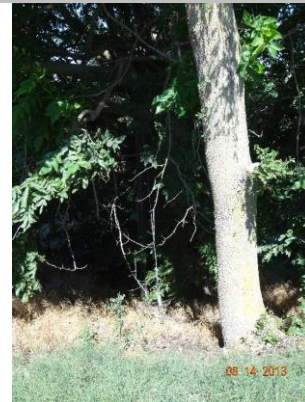
Photo 3 of 3 : UCIP_FA_2015_3545.jpg

View of landward side--power pole and guy wire under trees.

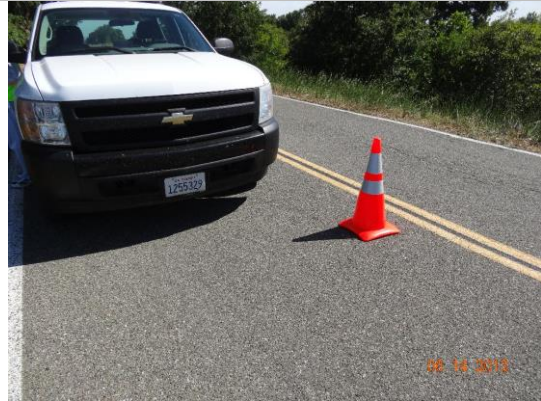
Photo 1 of 3 : UCIP_FA_2015_3546.jpg

View of levee crown at crossing.

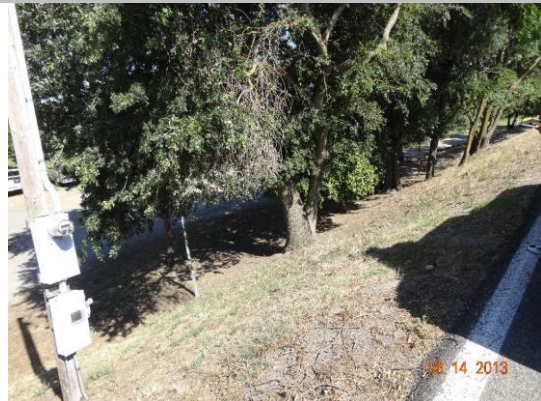
Photo 2 of 3 : UCIP_FA_2015_3547.jpg

View of landward side--power pole on slope.

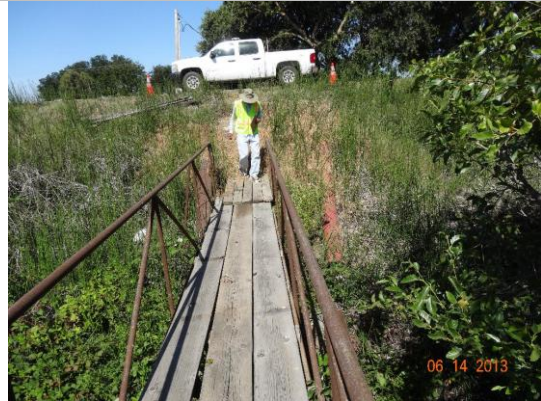
Photo 3 of 3 : UCIP_FA_2015_3548.jpg

Abandoned pipe to the right of walkway.

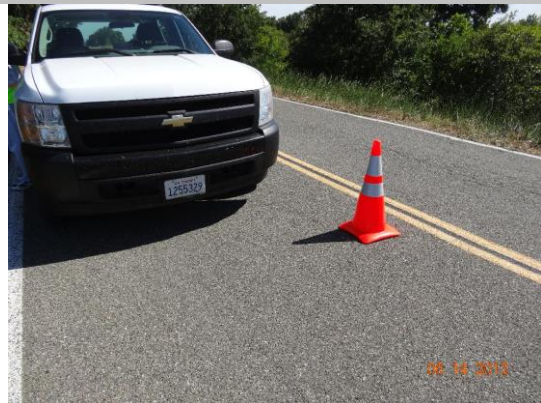
Photo 1 of 3 : UCIP_FA_2015_3549.jpg

LM Start	1.17	Rating **	M	Issue No.	72
LM End	1.17	Issue Type +	En	Location *	LS
Category	Supplemental			GPS Latitude/Longitude	
				Start	End
Item	DWR UCIP Field Study			38.270156 °	38.270156 °
				-121.604403 °	-121.604403 °
DWR ID					
Action/Comments					
Inspector Comments: FS_ID:32552 DS_ID:21095 EP_NO: 13983 FS_HLM: 1.2 Repair Type: Non-Urgent Crossing Status: Found UCIP Comments: Abandoned pipe was to be removed during the installation of new 12-inch pipe crossing. Need to contact pipe owner. Unable to confirm crossing--need additional records for crossing. FIELD_STRUCT_DESC: 12-inch steel pipe through the levee, 5.0 feet below the crown. Cutoff wall around pipe at center of levee. Siphon breaker on apex of pipe at landward shoulder. Pump on pile structure in stream. Service pole on landward slope. Pipe connects to 10-inch steel pipe along the landward slope at the shoulder, and similarly to pre-existing 8-inch pipe on the watereward side. (Permit No. 13983-1985) FS Date: 06/13/2013

View of levee crown at crossing.

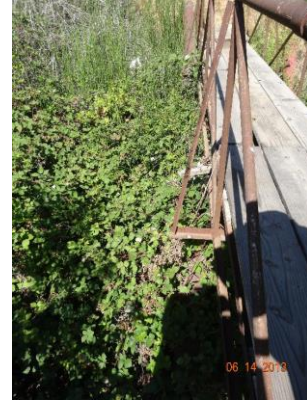
Photo 2 of 3 : UCIP_FA_2015_3550.jpg

Pipe suspended on waterward side along walkway.

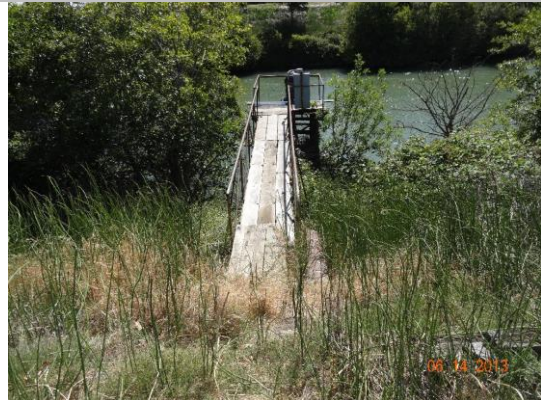
Photo 3 of 3 : UCIP_FA_2015_3551.jpg

View of waterward side--walkway, pump, conduit, and pipe.

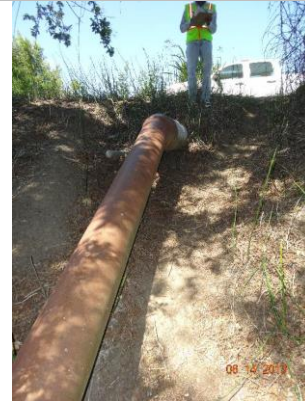
Photo 1 of 4 : UCIP_FA_2015_1738.jpg

Waterward side-pipe along slope.

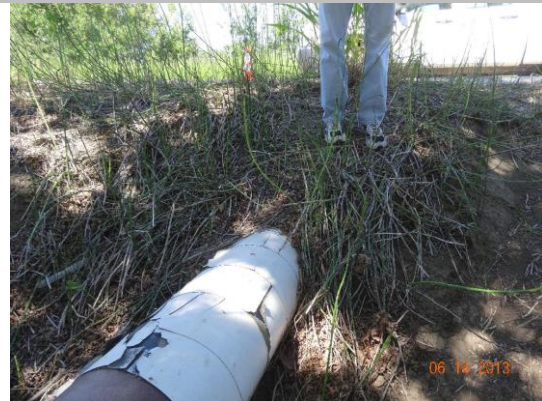
Photo 2 of 4 : UCIP_FA_2015_1739.jpg

Waterward side-pipe lined through levee.

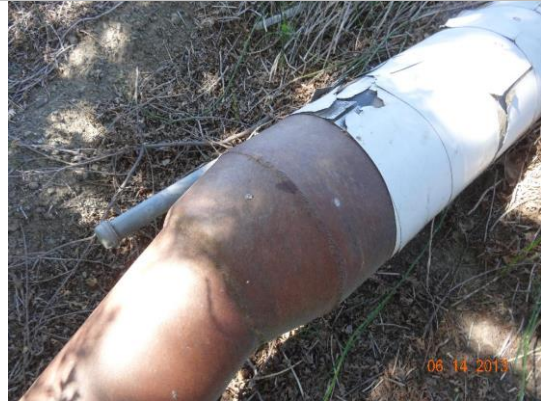
Photo 3 of 4 : UCIP_FA_2015_1740.jpg

Pipe section reduced at the waterward side daylight.

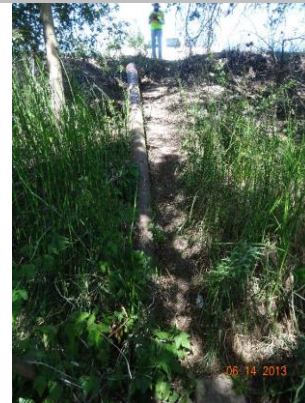
Photo 4 of 4 : UCIP_FA_2015_1741.jpg

Overview of waterward side.

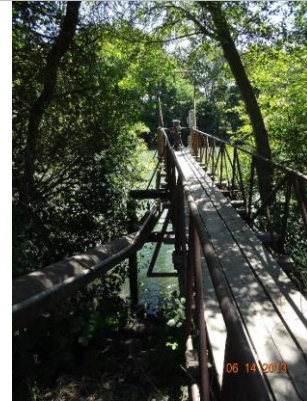
Photo 1 of 3 : UCIP_FA_2015_3552.jpg

LM Start	1.86	Rating **	M	Issue No.	74
LM End	1.86	Issue Type +	En	Location *	LS
Category	Supplemental			GPS Latitude/Longitude	
				Start	End
Item	DWR UCIP Field Study			38.260407 °	38.260407 °
				-121.601365 °	-121.601365 °
DWR ID					
Action/Comments					
Inspector Comments: FS_ID:32553 DS_ID:21077 EP_NO: N/A FS_HLM: 1.9 Repair Type: Non-Urgent Crossing Status: Found UCIP Comments: Dense vegetation limits the inspector's visibility to identify signs of pipe failure (leaks) along the waterward and landward slope. Recommend removing vegetation along pipe alignment to conduct proper inspection of structure and appurtenances. FIELD_STRUCT_DESC: 14-inch steel pipe through the levee, 8.0 feet below the crown. 2 inch conduit goes through levee. Siphon breaker on landward slope. Pump on pile structure in stream. (USACE-1959). This entry matches the Drainage or Irrigation Structure referenced in O&M manual (HLM 2.0). FS Date: 06/13/2013

Waterward side--catwalk, conduit line, pump, and support piles.

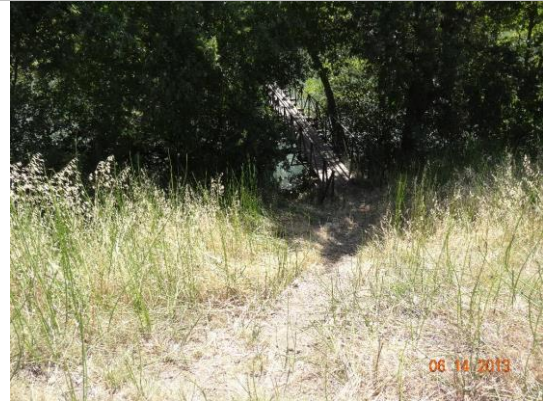
Photo 2 of 3 : UCIP_FA_2015_3553.jpg

View of waterward side.

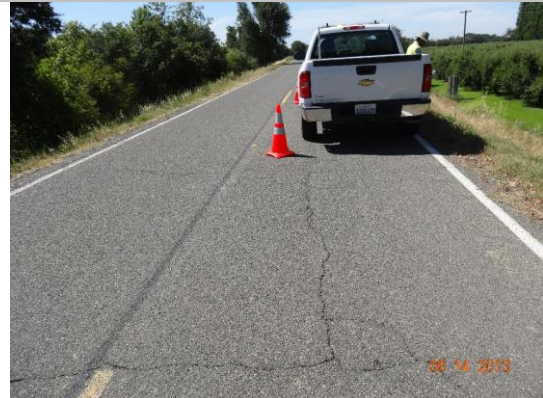
Photo 3 of 3 : UCIP_FA_2015_3554.jpg

View of levee crown at crossing.

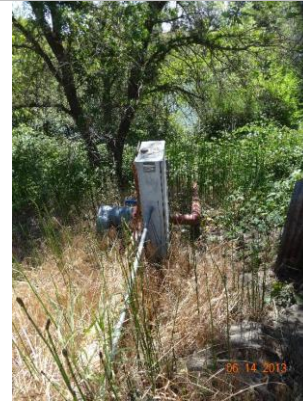
Photo 1 of 3 : UCIP_FA_2015_3926.jpg

LM Start	2.16	Rating **	M	Issue No.	75
LM End	2.16	Issue Type +	En	Location *	LS
Category	Supplemental			GPS Latitude/Longitude	
				Start	End
Item	DWR UCIP Field Study			38.256225 °	38.256225 °
				-121.600903 °	-121.600903 °
DWR ID					
Action/Comments					
Inspector Comments: FS_ID:32863 DS_ID:21078 EP_NO: N/A FS_HLM: 2.19 Repair Type: Non-Urgent Crossing Status: Found UCIP Comments: Broken concrete box on landward slope. Disturbed soil on waterward slope--unable to determine section disturbed. Dense vegetation limits the inspector's visibility to identify signs of pipe failure (leaks) along the waterward slope. Recommend removing vegetation along pipe alignment to conduct proper inspection of structure and appurtenances. FIELD_STRUCT_DESC: Abandoned 6-inch and working 6-inch steel pipes through the levee, 2.5 and 5.0 feet below the crown, respectively. 1.5 inch electrical conduit through levee. Pump in pump house on waterward slope. (USACE-1959). This entry matches the Drainage or Irrigation Structure referenced in O&M manual (HLM 2.30). Pipes are within 5 feet. FS Date: 06/13/2013

View of waterward side--conduit, pump, control panel, and pipe. Soil piled on right corner of photo--excavation?

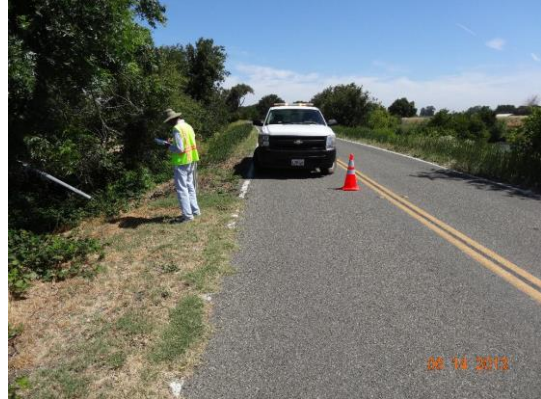
Photo 2 of 3 : UCIP_FA_2015_3961.jpg

View of levee crown at crossing.

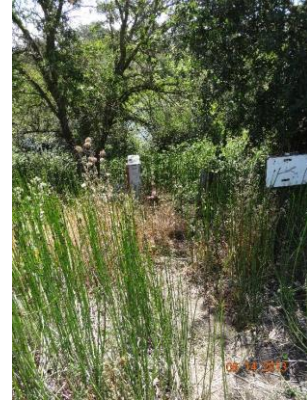
Photo 3 of 3 : UCIP_FA_2015_3962.jpg

View of waterward side with dense vegetation along slope.
